The Biological Reconnaissance Survey Report by ECORP Consulting, Inc. and the Wetland Delineation report by ECORP Consulting Inc.

RE: 4659 Proctor Road, Castro Valley, California- Biological Reconnaissance Survey

Wetland Delineation
FOR
Proctor Road Property
5.85± Acre
ALAMEDA COUNTY, CALIFORNIA

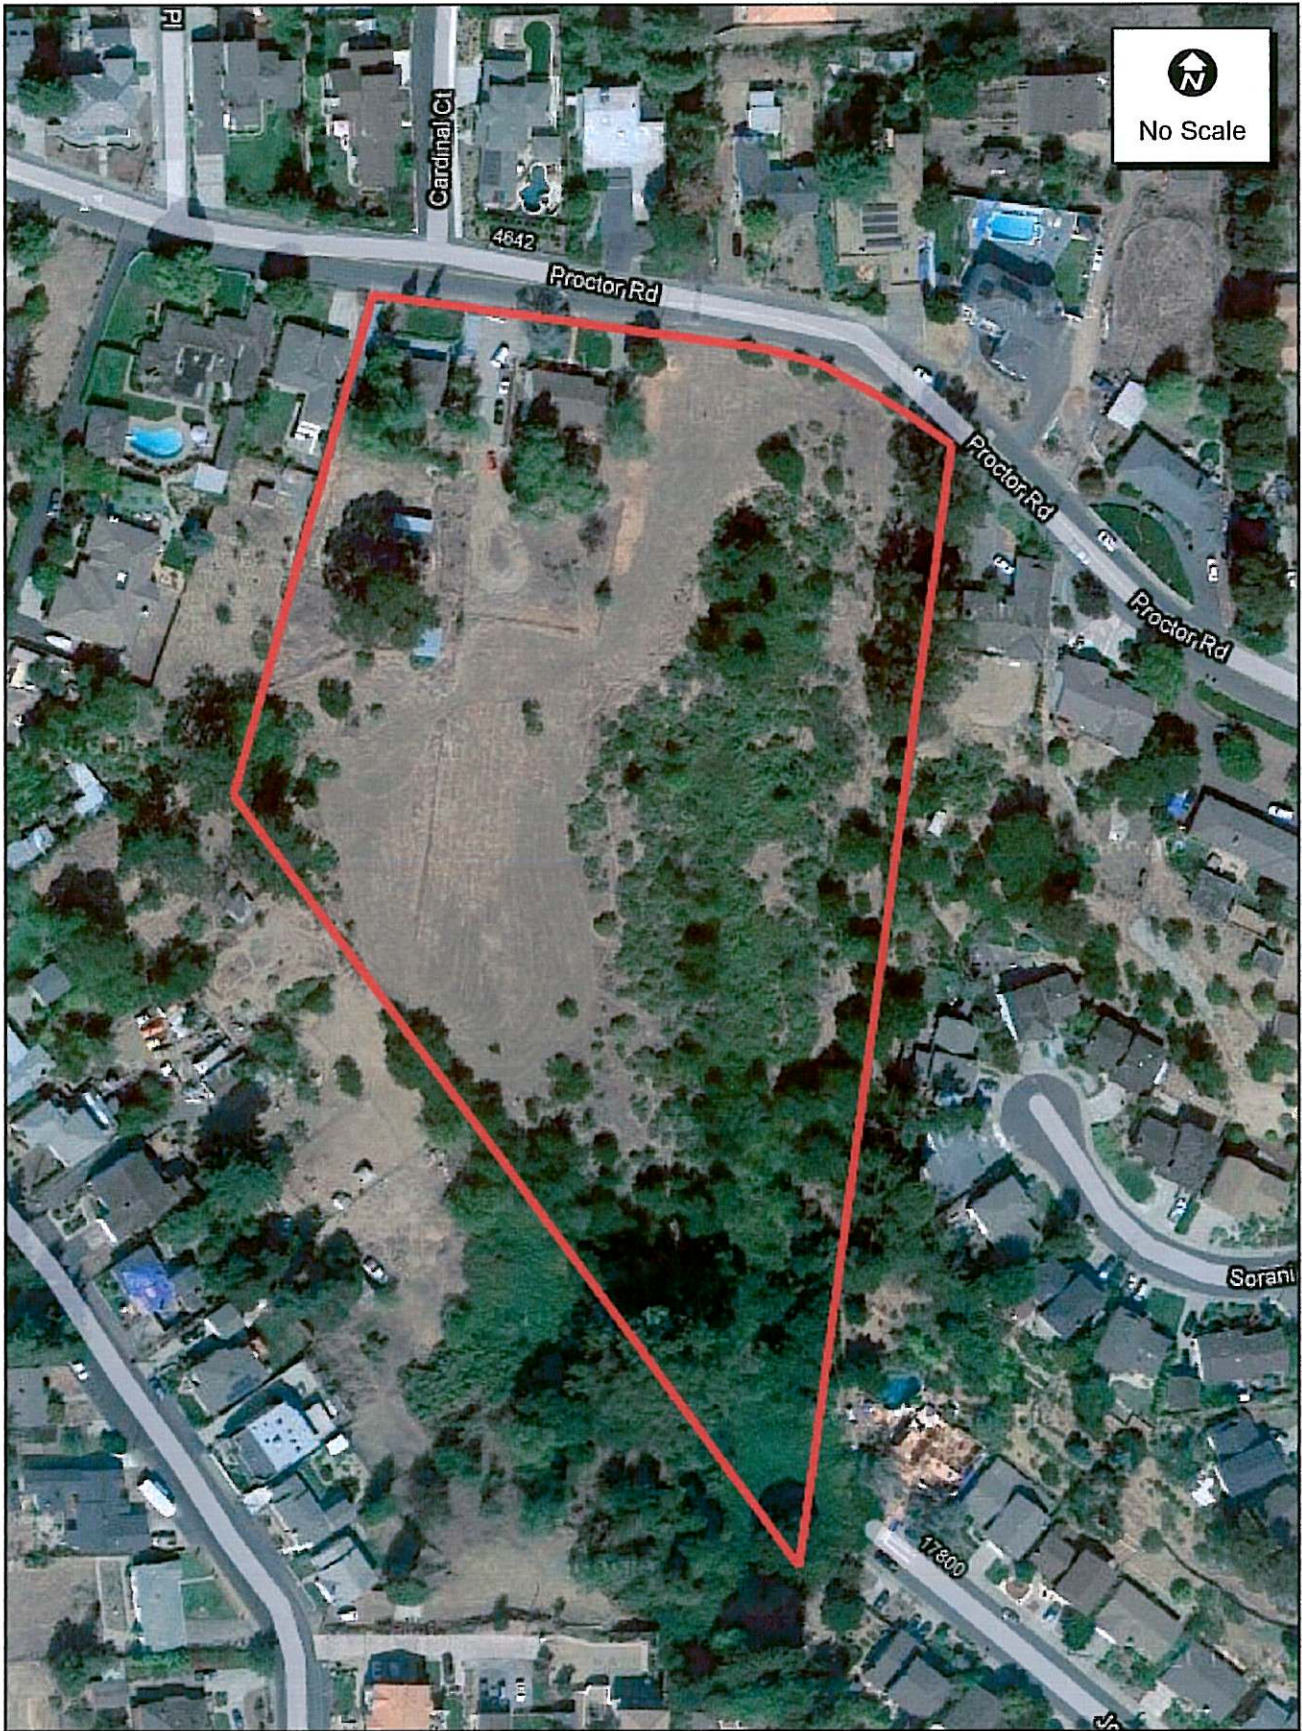
FIGURE 2. Aerial View of Project Site

The subject property consists of two residences (4659 and 4651 Proctor Road) and associated land (comprising 5 separate parcels) totaling approximately 6.8-acres. The property is relatively flat where the existing houses are located. The property then slopes steeply to the south and southeast. A broad topographic swale (which trends in a north to south direction) is located in the eastern portion of the site (Figure 3. *Topographic Survey*). The southern-most tip of the property corresponds to the lowest elevation on site. The property drains via an existing storm drain at that point. Representative photographs of the property are attached (see Attachment A – *Plates 1 and 2*).

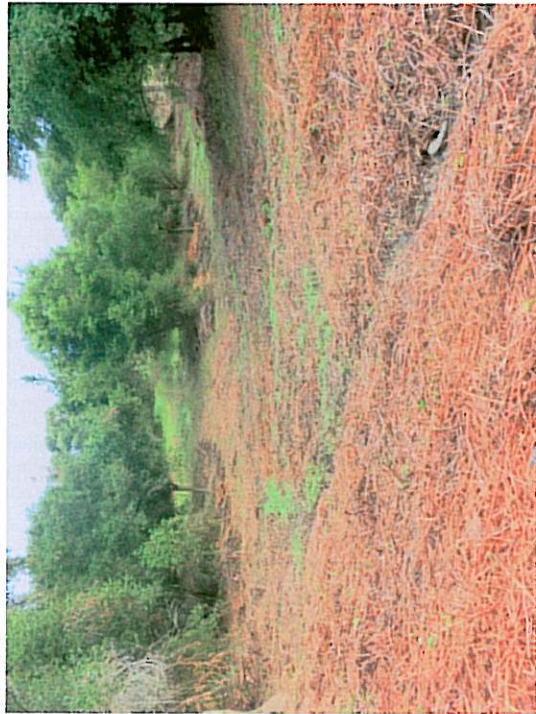
Lowest portion of property (southern tip) at storm drain area.

One seasonal wetland is present within the southern-most corner of the site, just upstream of an existing storm drain (Figure 3). The seasonal wetland is located within the southern portion of the property, which corresponds to the lowest topographic area on site. The wetland receives runoff from upslope areas on site as well as from runoff from adjacent properties/residences. Its presence is the result of existing drainage patterns from the upslope watershed and adjacent developments. Representative photographs of the seasonal wetland and downstream culvert are included as Attachment D. Dominant plants within the on-site seasonal wetland include Himalayan blackberry (*Rubus armeniacus*), common sheep sorrel (*Rumex acetosella*), and iris-leaved rush (*Juncus xiphioides*). Other species commonly observed in the seasonal wetland include apple mint (*Mentha suaveolens*), curly dock (*Rumex crispus*), tall flat sedge (*Cyperus eragrostis*), and bull thistle (*Cirsium vulgare*). Vegetation within the seasonal wetland was determined to be hydrophytic due to passage of the dominance test.

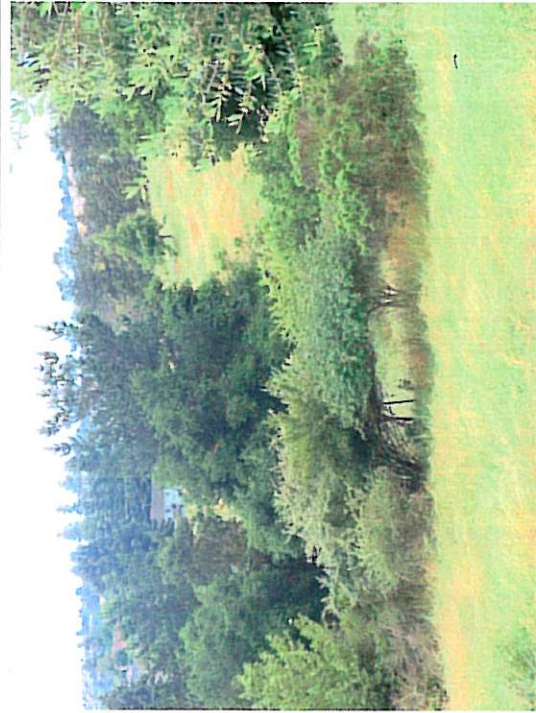
View of property from Proctor Road, looking from the northeast to southwest direction.

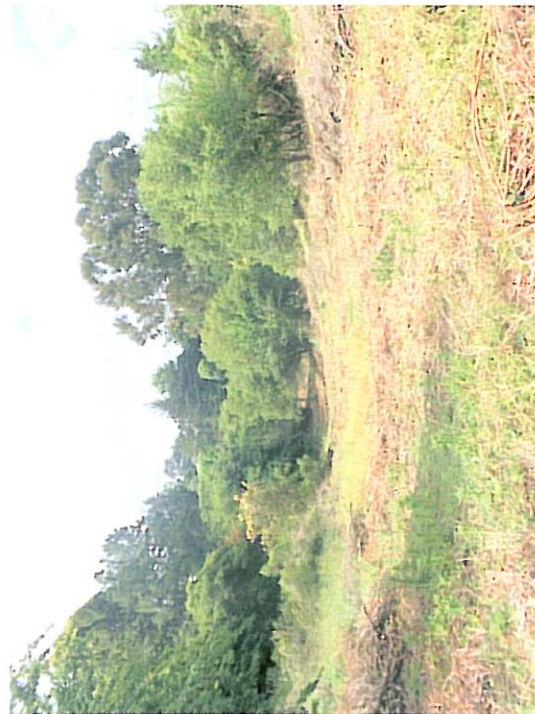
Downslope view of cleared area within eastern swale.

The broad and sloped topographic swale located in the east portion supports many of the afore mentioned plant species, including a large recently cleared stand of Himalayan blackberry (*Rubus discolor*). It is my understanding that the extensive blackberry growth along the swale and in the southern-most portion of the site was recently cleared for fire prevention purposes as requested by the Planning Department. This clearing has resulted in a more open and currently sparsely vegetated area. Signs of blackberry regrowth are evident at various locations along the swale and southern portion of the property. There is no evidence of a naturally occurring "bed and bank" drainage within the swale. At the southern-most terminous of the property, a very small recently excavated ditch is evident immediately above an existing storm drain outlet which helps facilitate site drainage. In reviewing topographic data for the site and adjacent areas it is evident that an additional small swale traverses the southern-most terminous of the site in west-east direction. The project site drains via overland flow along slopes and the eastern swale. Some runoff from offsite lands to the south and west may also occur during rain events. Some small puddles were evident in the southern-most portion of the site on the survey date, the likely result of recent rains the day and evening before. This low lying area is relatively wet compared with other areas of the site and it is clearly evident that the site drains from this point. While much of the vegetation (primarily blackberry) has been cleared, some blackberry regrowth was evident and blackberry shrubs will likely become reestablished over time. Other plants observed in the low lying area included poison oak, plum, curly dock (*Rumex crispus*), geranium (*Geranium dissectum*), nutsedge (*Cyperus* sp.), toad rush (*Juncus bufoneus*), loosestrife (*Lythrum* sp.), and scarlet pimpernell (*Anagallis arvensis*). Some of these species are facultative wetland species and given the apparent seasonally wet conditions at the southernmost drainage area, it is possible that wetland indicator species may persist in this low area due to the current absence of blackberry cover. Fill of verified jurisdictional wetlands and waters of the U.S. is regulated by the U.S. Army Corps of Engineers under Section 404 of the Clean Water Act. It is my understanding, however, that the proposed project has been designed to avoid building in this southern-most area, and that the lower portion of the site will continue to serve in a drainage capacity.

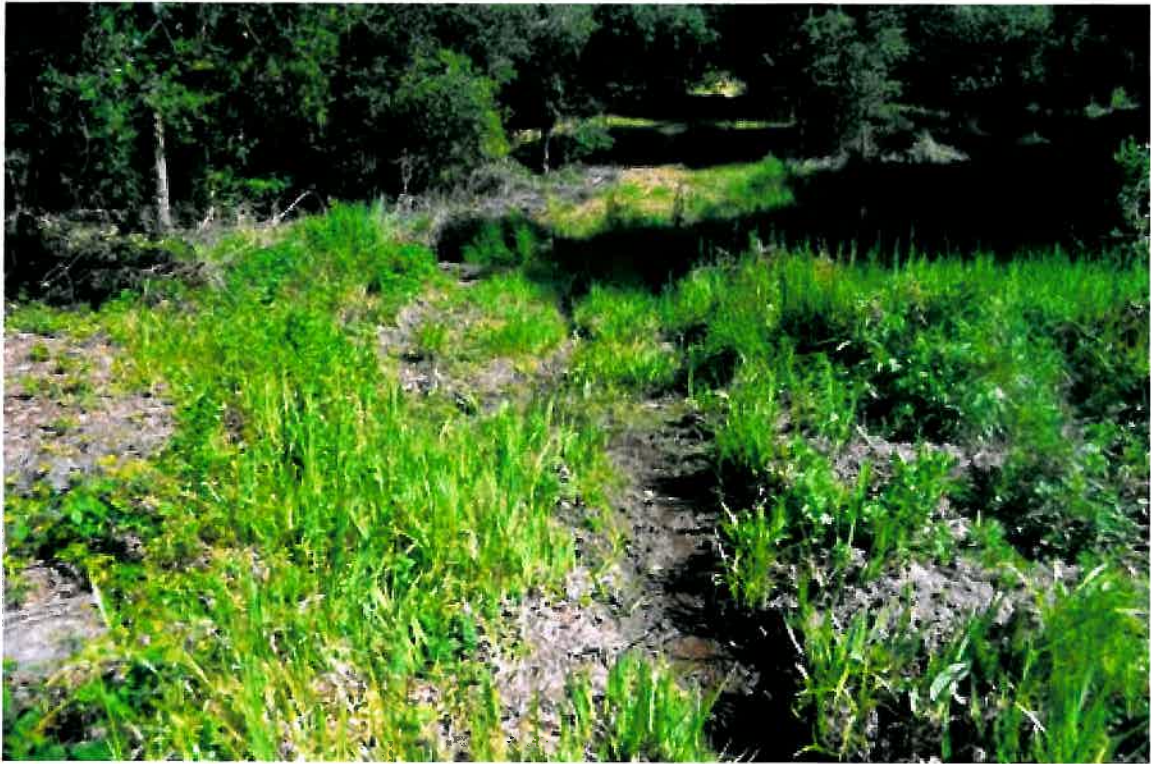
Seasonal wetland, 5/07/12.

Indicators of wetland hydrology observed within the seasonal wetland include oxidized rhizospheres and soil saturation within 12 inches of the soil surface. The soil matrix color within the seasonal wetland was 2.5Y2.5/1 without redox features 0 to 7 inches below the surface and 2.5Y3/1 with 10% redox concentrations colored 10YR4/6 from 7 to 12 inches below the surface. The soil was determined to be hydric based on the presence of field indicator F6 (redox dark

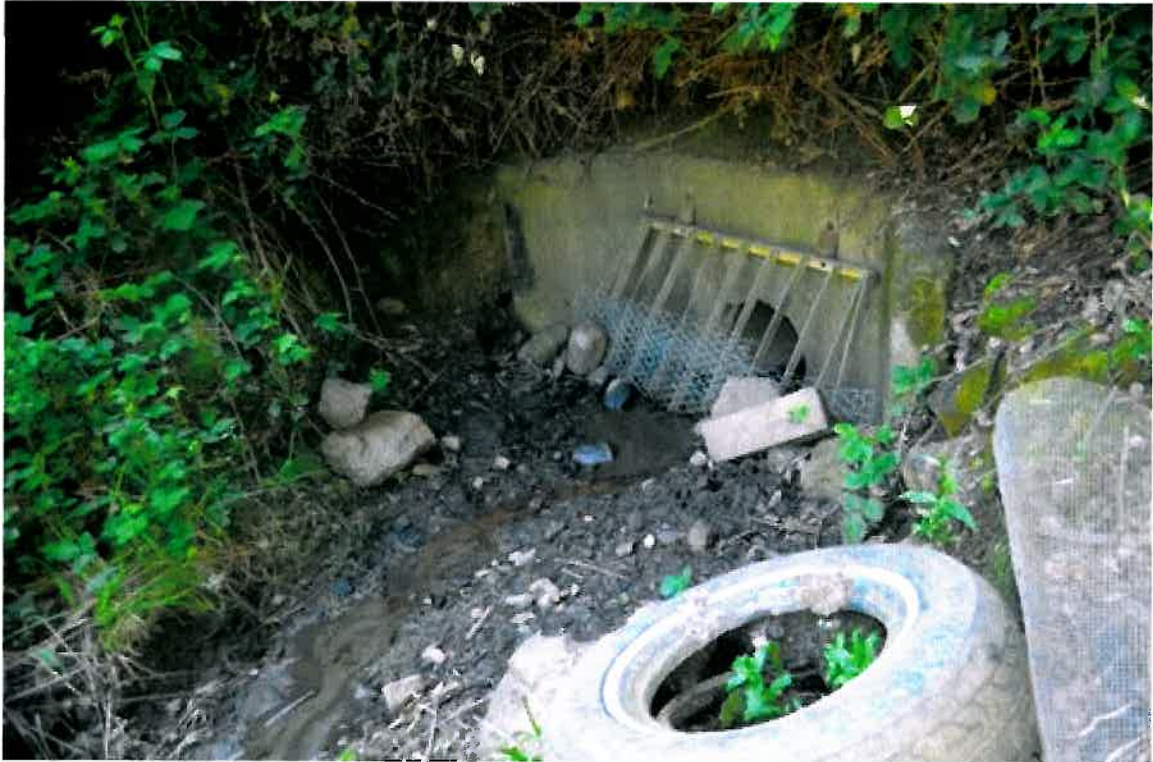
Culvert/drain, 5/07/12.

The seasonal wetland on-site drains south into a storm drain, which is presumed to flow eventually into San Lorenzo Creek, which is tributary to the San Francisco Bay, a navigable water. San Lorenzo Creek is a relatively permanent water. The seasonal wetland on-site does not abut San Lorenzo Creek, but would be considered adjacent. As the seasonal wetland is adjacent but not abutting a relatively permanent water, a significant nexus determination will likely be required by the USACE and USEPA to establish jurisdiction. It should be noted that
