Northbrook Homes Fairview Site

24850 Fairview Avenue

PRELIMINARY GEOTECHNICAL INVESTIGATION
BOREL BANK PROPERTIES RESIDENTIAL SUBDIVISION
FAIRVIEW AVENUE
HAYWARD, CALIFORNIA

FOR
NORTHBROOK HOMES, LLC
July 8, 2010

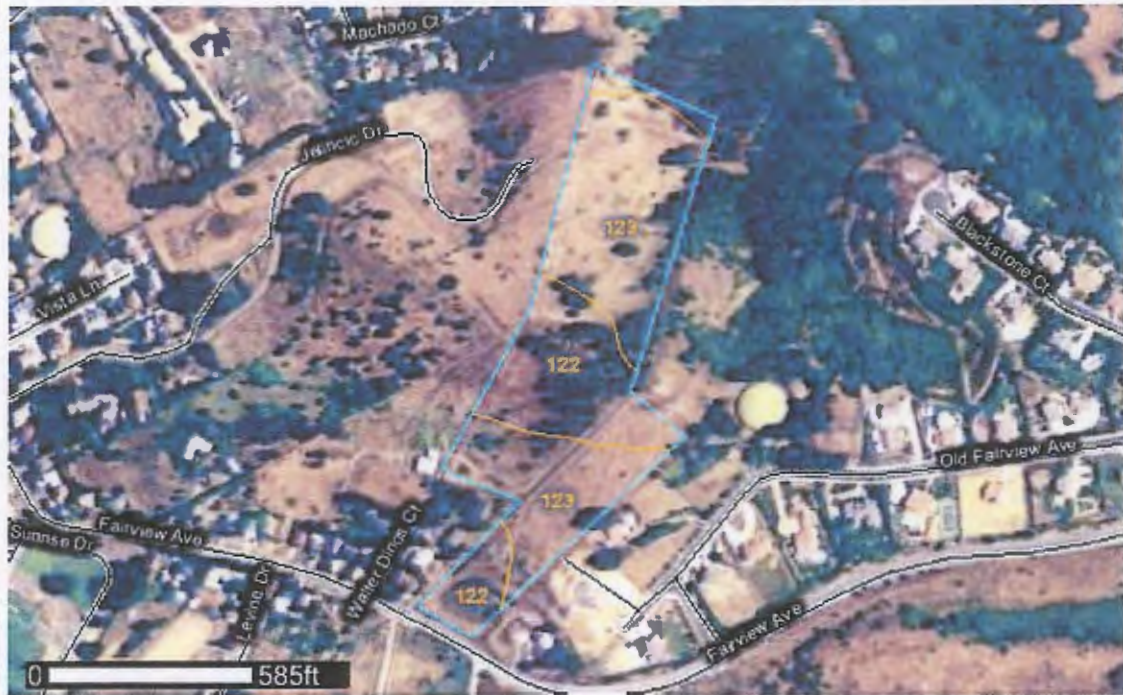
Figure 8
Soils Map

The NRCS (2010) reports two soil type within the Property. A detailed map of this soil type can be found in Attachment 1, Figure 8. The soils mapped included the following type:

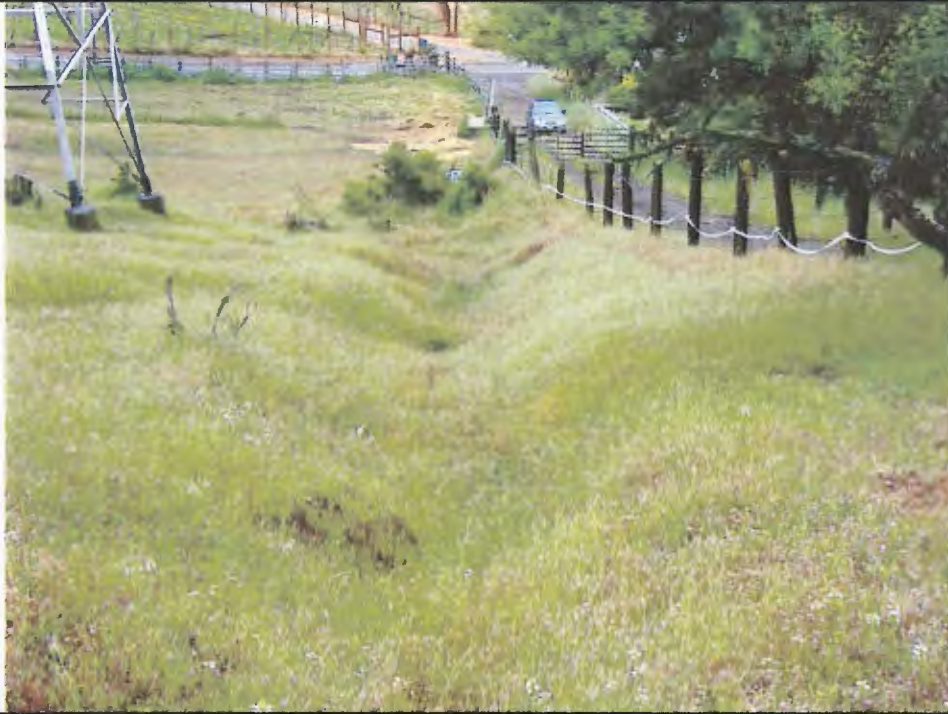
Photo 1. View to the south of the incised drainage ditch along the western fence line.

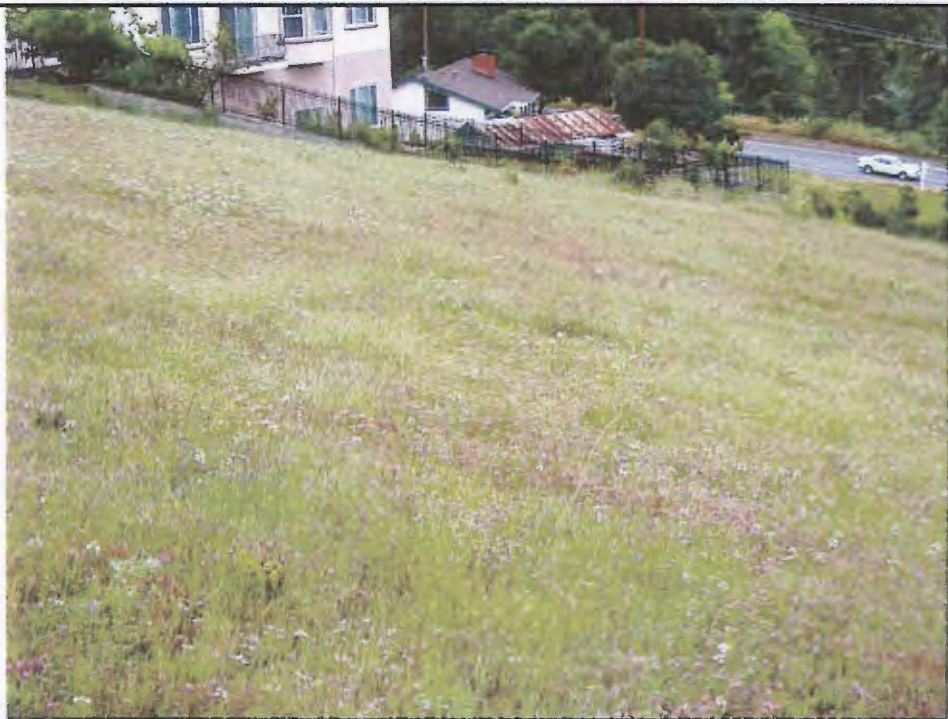
Photo 2. View of the non-native annual grassland habitat near the southeastern portion of the Property.

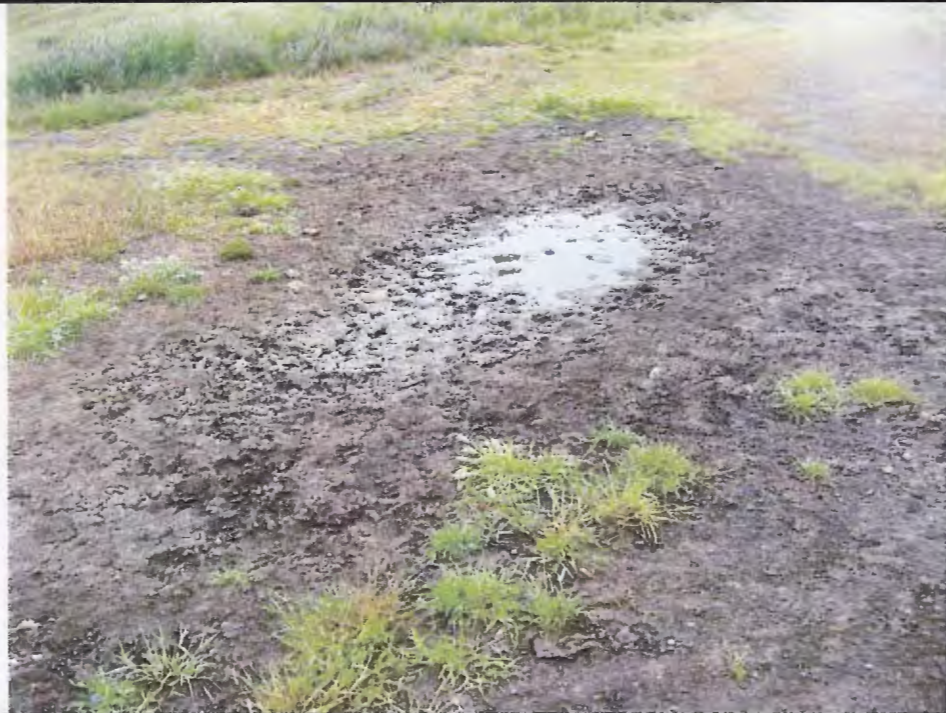
Photo 4. View of the small potential seasonal wetland located near the western Property boundary.

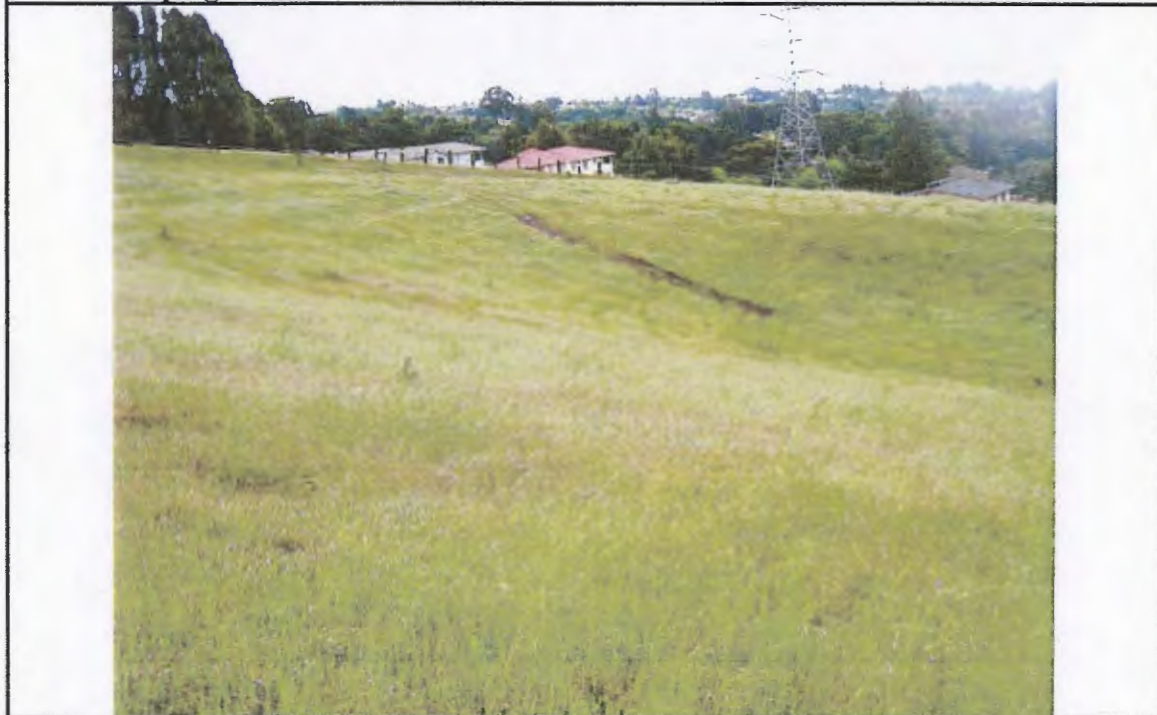
Photo 6. View to the south of the hillside containing the potential seasonal wetland seep.

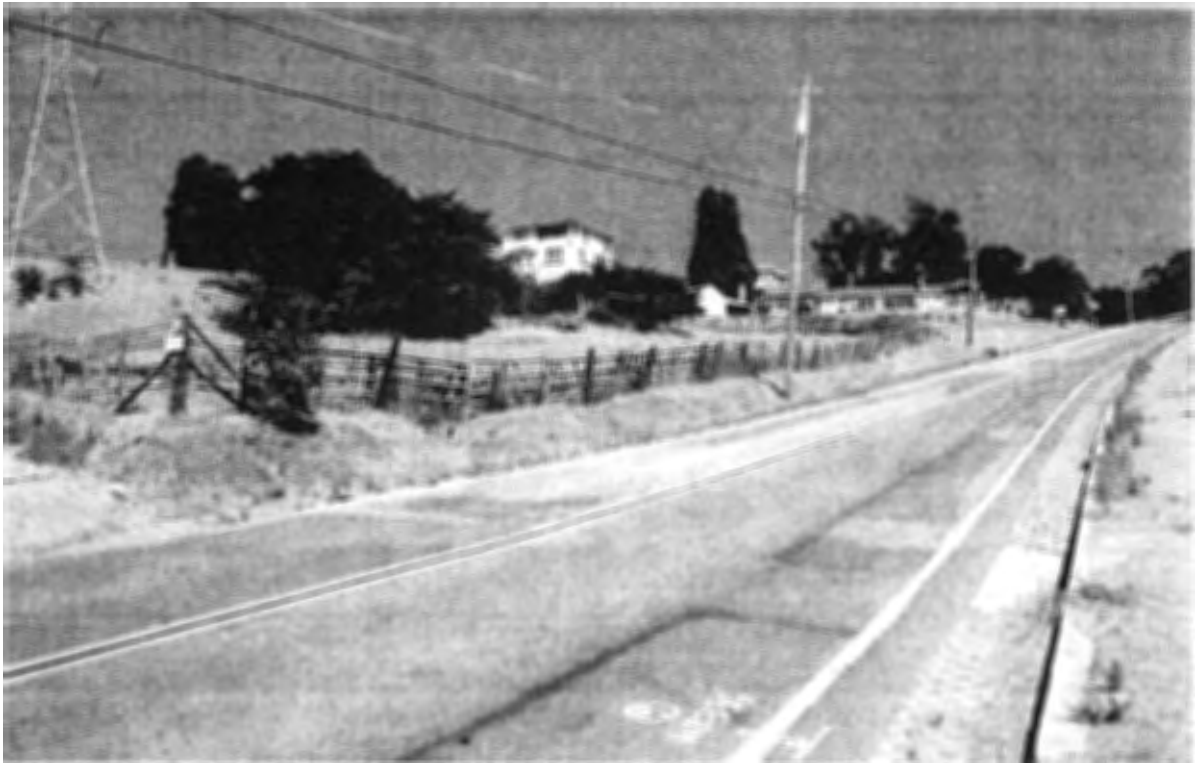
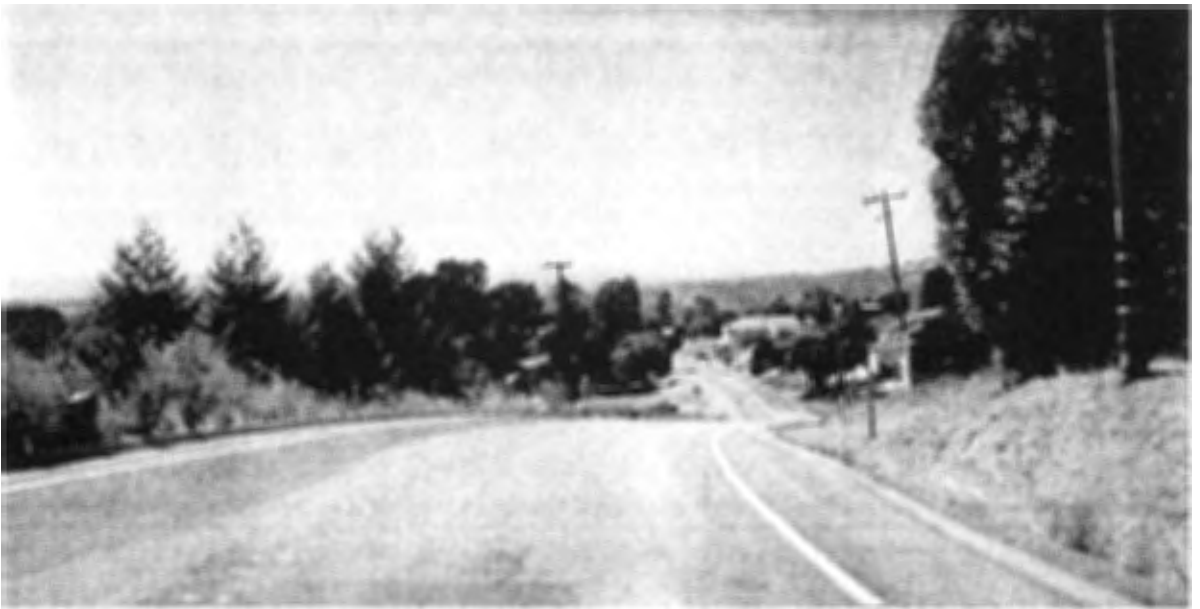
In the first photo, the proposed location of the project driveway is at the far left edge at the asphalt driveway. The view is uphill and shows the downgrade and the curves that limit the sight distance at the top of the hill. The second photo shows the downhill view with the proposed driveway not quite in view.

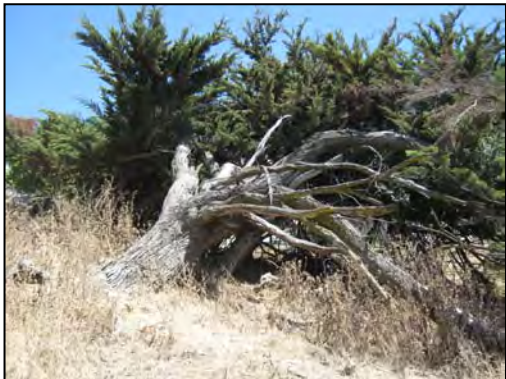
Photo 1: 35" Monterey cypress has failed and should be removed.

There are three trees that meet the definition for protected trees: three mature Monterey cypress (*Cupressus macrocarpa*) (photos 1 and 2). While native to California, they are not native to this area. These trees are located on the south end of the property. The Preliminary Grading Plan (RJA Aug. 1, 2011) indicates Street A will be placed between the tree in photo 1 and the group in photo 2. The graded slope is through the trunk of the failed tree and will remove it. To preserve the two trees on the west side of the road, adjust the grading so that natural grade is maintained within the dripline of the group.

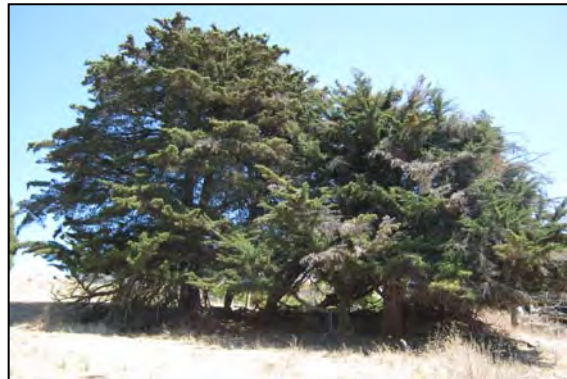
Photo 2: Two Monterey cypress trees, 30" and 37" in diameter.

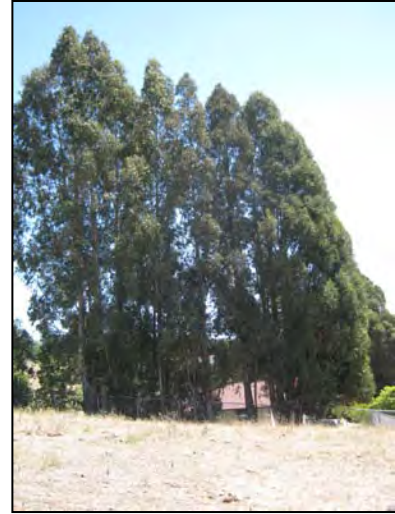
Photo 3: Off-site blue gums.

Outside the east property line several feet there is a group of large, mature blue gums (*Eucalyptus globulus*) (Photo 3). These would be impacted by grading for Street A. I recommend adjusting the grading so that natural grade is maintained within the driplines of these trees.
